# Can You Identify Problem Vegetation Before It Fails? We Can!

# Finding High-Risk Vegetation Using CartoVid & Multispectral Imaging Use Case

## Use Case From Eastern U.S. Electric Utility

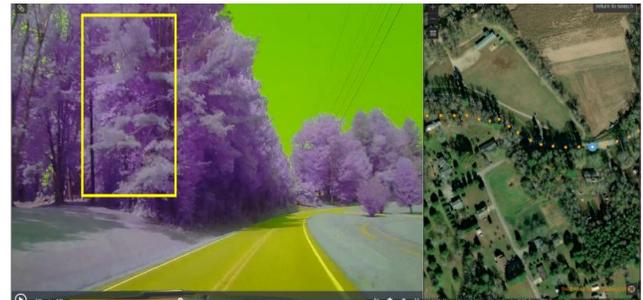
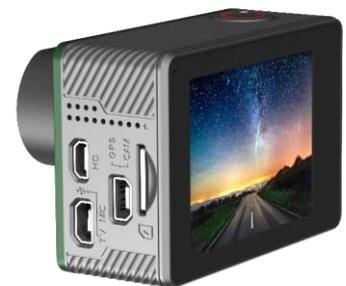
Multispectral imaging can pick up instances of unhealthy vegetation before it is readily apparent to the naked eye. Aside from normal aging-related decline, other factors such as infestation, disease, weather, and even environmental hazards can contribute to and accelerate vegetation decline. Multispectral cameras provide a cost-effective way of capturing GPS-enabled data to determine vegetation health. The dashboard-mounted camera used in the image above was approximately \$400.

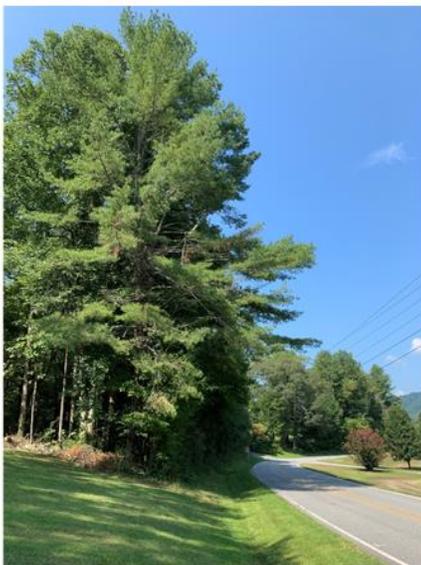
View of Tree From Human Eye

A multispectral video of the distribution network right of way was captured from a vehicle's dashboard. From there, Theorem Geo ran video analytics through the CartoVid data analytics platform and provided the client with actionable insights of high-risk trees identified; both the latitude and longitude and corresponding video evidence.

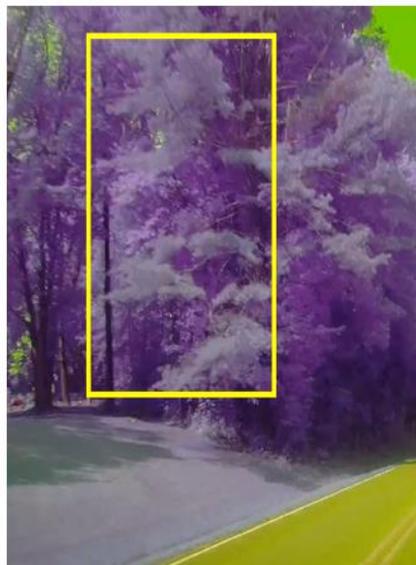
Multispectral Image from CartoVid

Multispectral imagery uses wavelengths not visible to the human eye, and it is how pollinators see the world around us. Multispectral imagery captures the amount of reflectivity of sunlight from vegetation; the reflectivity is determined by the amount of chlorophyll in a plant leaf and indicates vegetation health.

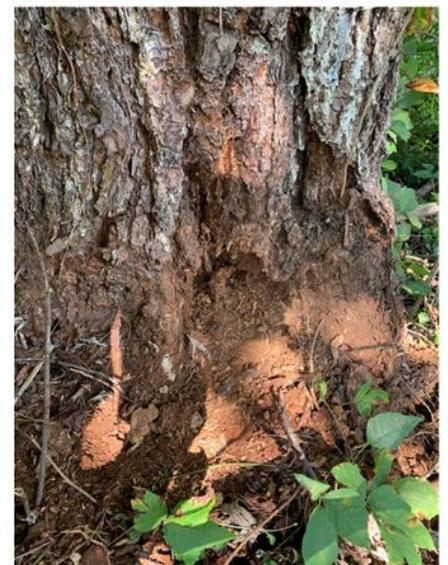
Arborist Inspection Confirms Rotted Base

An arborist from ArborMetrics Solutions, a recognized industry leader that leverages software, hardware, and people into mobile workforce solutions to streamline vegetation management programs and who the utility uses for work planning, investigated the trees, identified, and confirmed the findings. This utility was on a five-year maintenance cycle, and the area in question was pruned approximately three years ago.

The arborist also stated that the high-risk situation in this example would not have been flagged during the last maintenance cycle in that area. A work order was issued to remove the vegetation before impacting the circuitry.
